Prediction of Stage, Bathymetry, and Riparian Vegetation of the
Lower Olentangy River After Removal of the Fifth Avenue Dam

Alexandra C. Naegele
School of Environment and Natural Resources

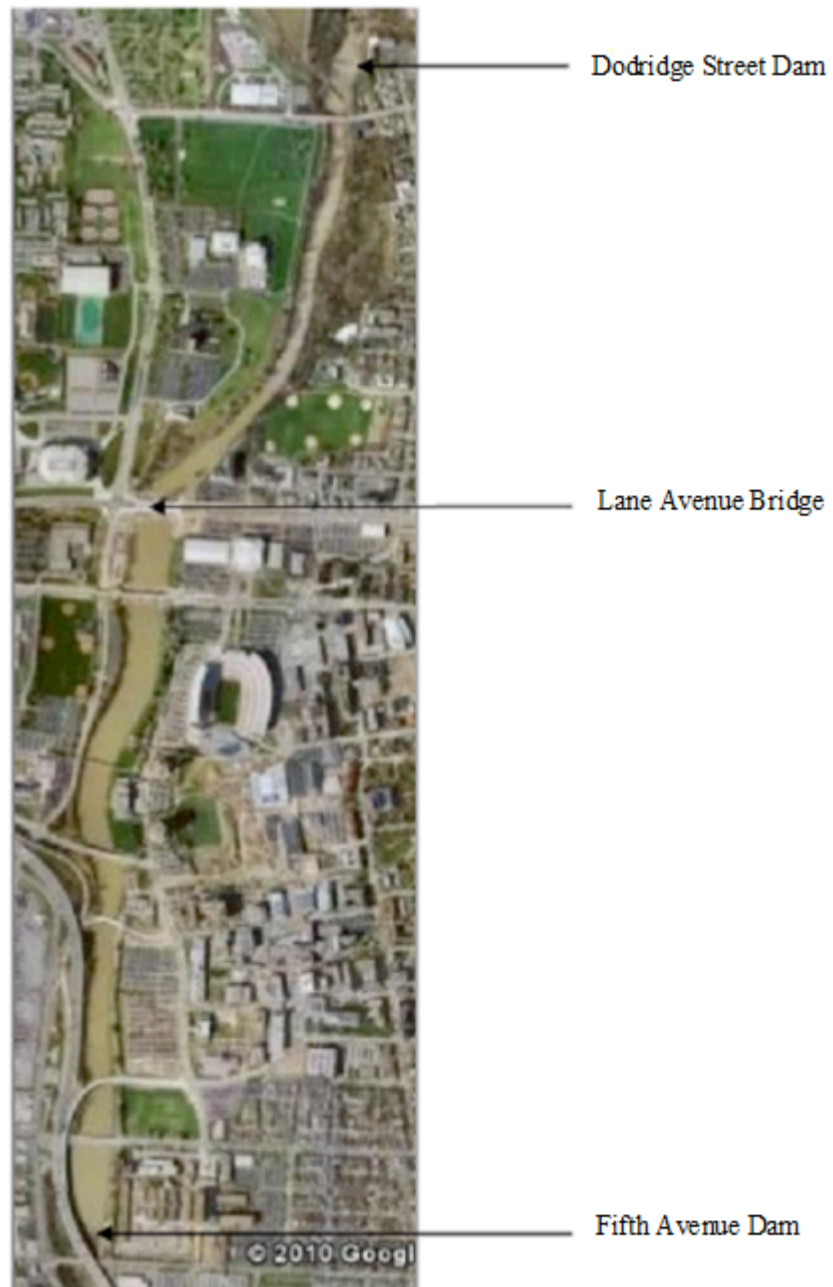
Figure 1. Map of the pool on the Olentangy River impounded by the Fifth Avenue Dam, bounded upstream by the Dodridge Street Dam.

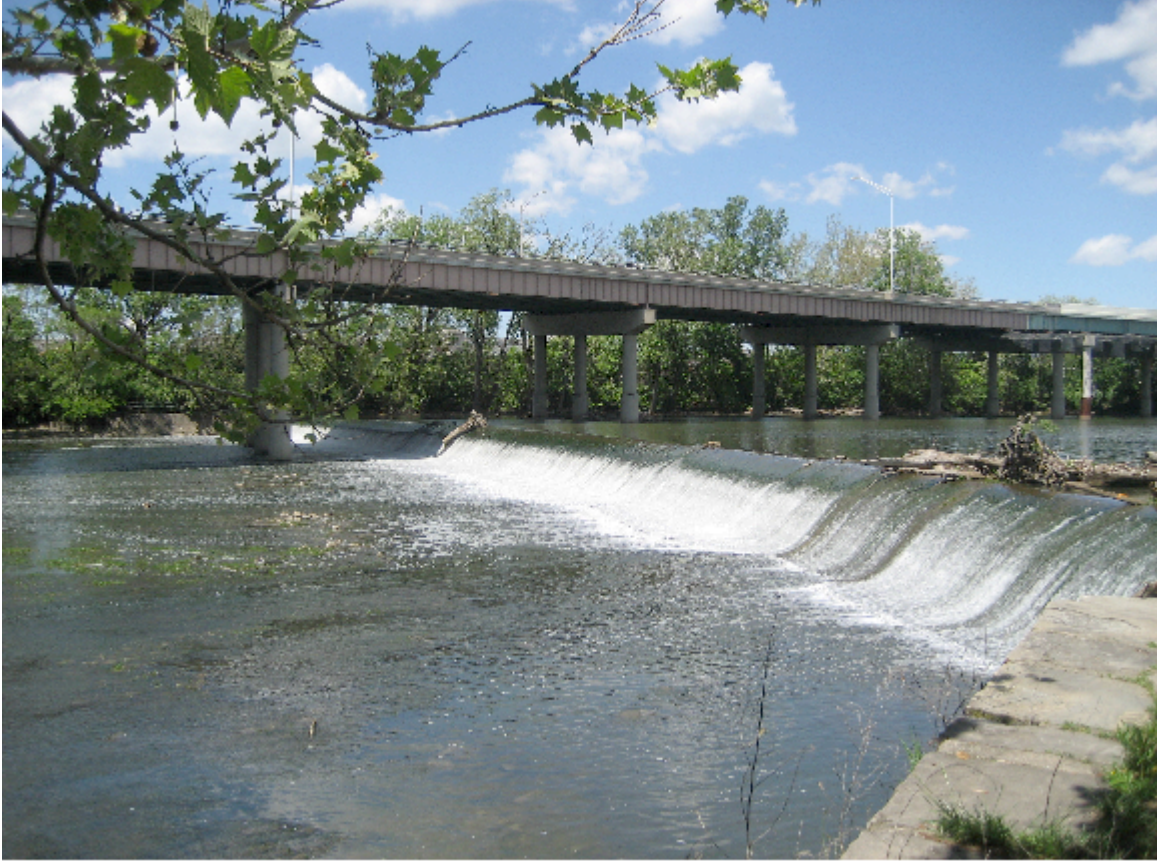
Figure 2. Fifth Avenue Dam and a portion of the upstream created reservoir. (photograph by Alexandra Naegele)

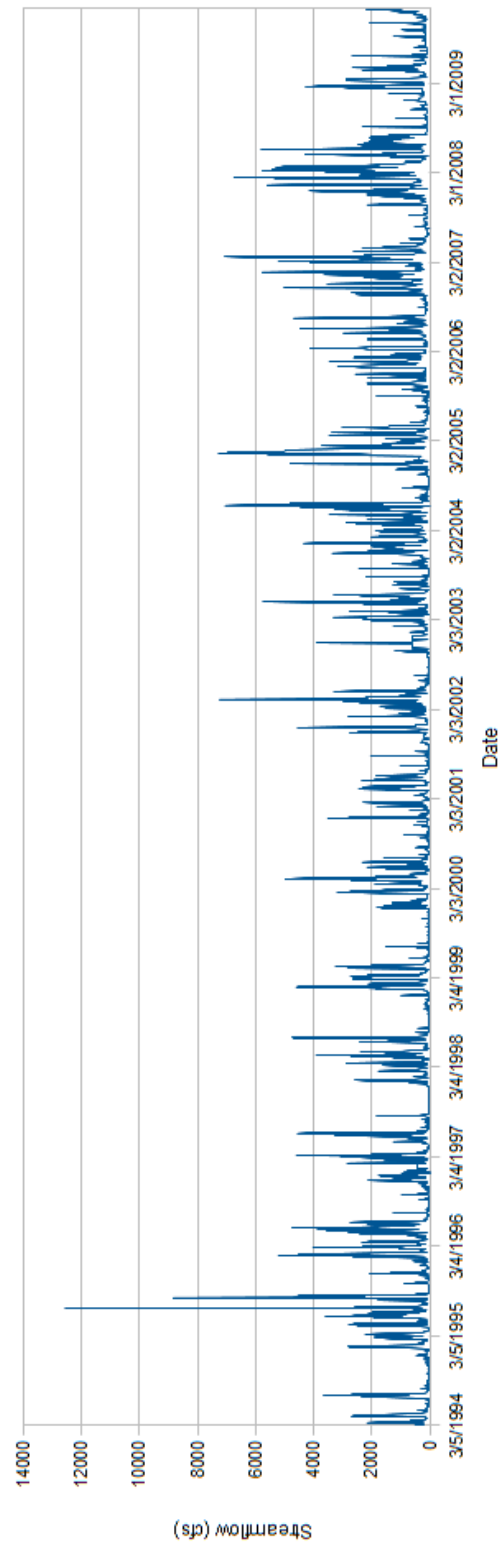
Figure 3. Olentangy River streamflow measured at the Clinton Park weir, ORWRP, 1994-2009.

For the past 16 years (1994-2009), there has generally been an annual high flow in the Olentangy River at the ORWRP in the spring out of several flood events, which result from high precipitation events and sometimes spring thawing, though flood events are distributed throughout the year (Figure 3).

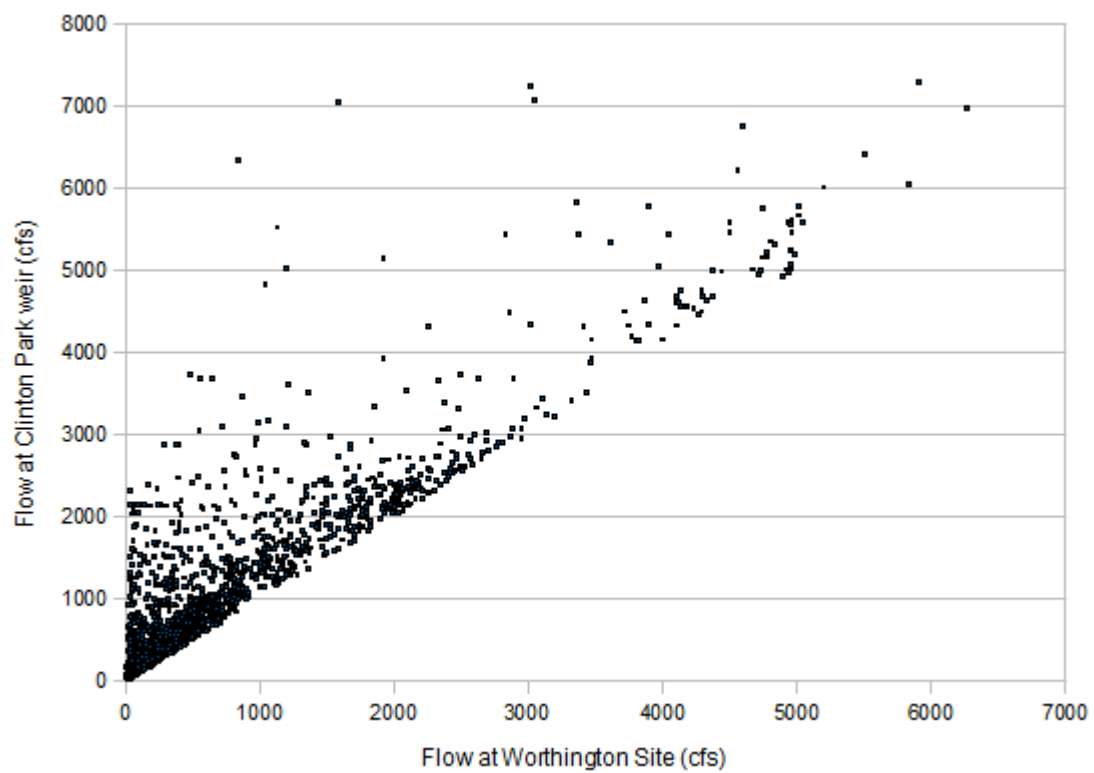
Figure 4. Comparison of average daily flow of the Lower Olentangy River measured at the USGS Worthington site and the Clinton Park weir, ORWRP.

Flows from the Clinton Park weir, in comparison to those from the Worthington site, were not as similar as expected (Figure 4), and can be approximated by the following linear relationship ($R^2 = 0.84$):

$$Q_{cp} = 1.16 Q_w + 164$$

It is important to note that this relationship only accounts for the set of data pairs in which the Clinton Park site measured a flow higher than that measured at the Worthington site. For data pairs in which the Worthington site measured a higher flow, the Worthington flow value was considered incorrect and the pair was eliminated from the regression. This modification to the dataset was made to account for the expectation that the more downstream site should have a higher flow. Although there are no major tributaries that flow into the river between the two

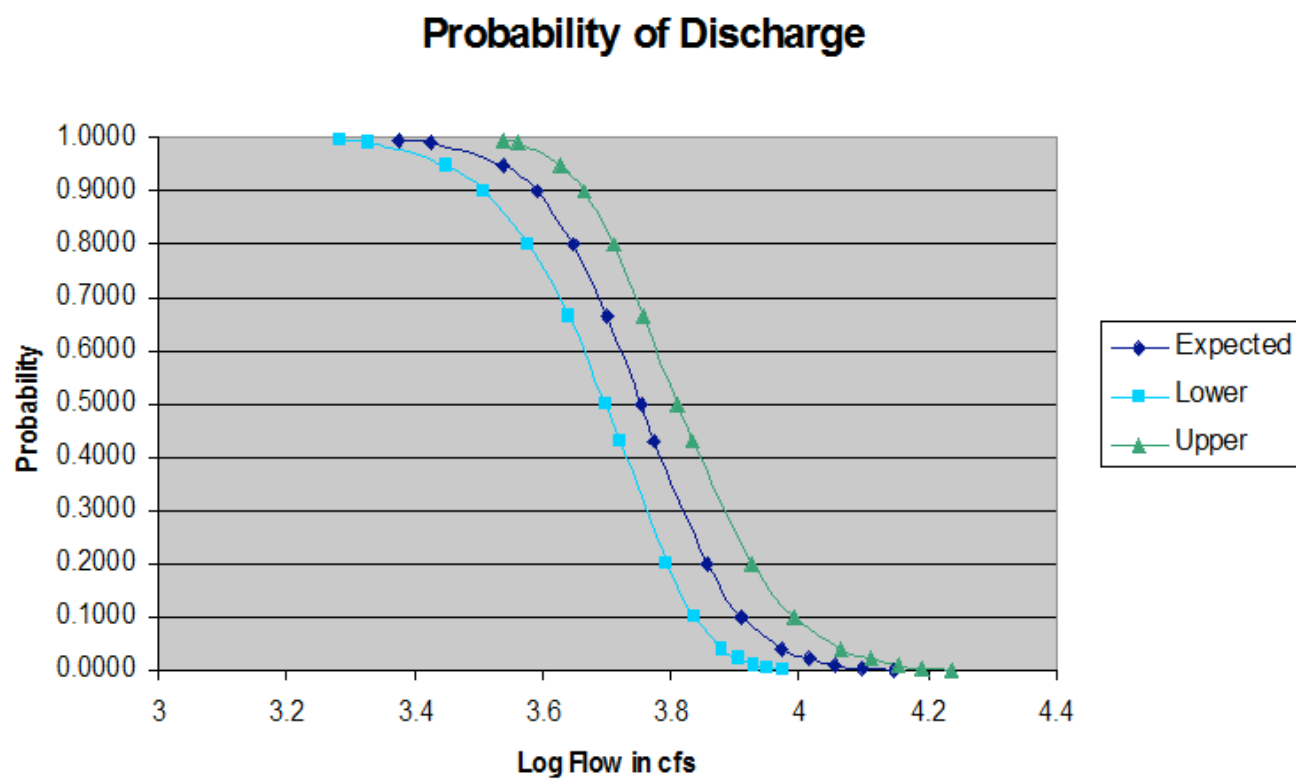
Figure 5. The occurrence probabilities of Olentangy River streamflows.

The Log Pearson Type III Distribution (Figure 5), commonly used in hydrologic studies, is similar to the normal distribution, however it includes skew in the calculation, in addition to mean and standard deviation and is commonly used in extreme event hydrologic analysis (Chow 1959). Lower and upper confidence intervals ($\pm 95\%$) are also illustrated. Each probability represents the chance that a flood event reaching a given streamflow will occur in one year. During the 16-year span of data collection, the five-year flood occurred twice, the two-year flood occurred ten times, and the ten-year (8,845 cfs) and one-hundred-year (12,576 cfs) floods each

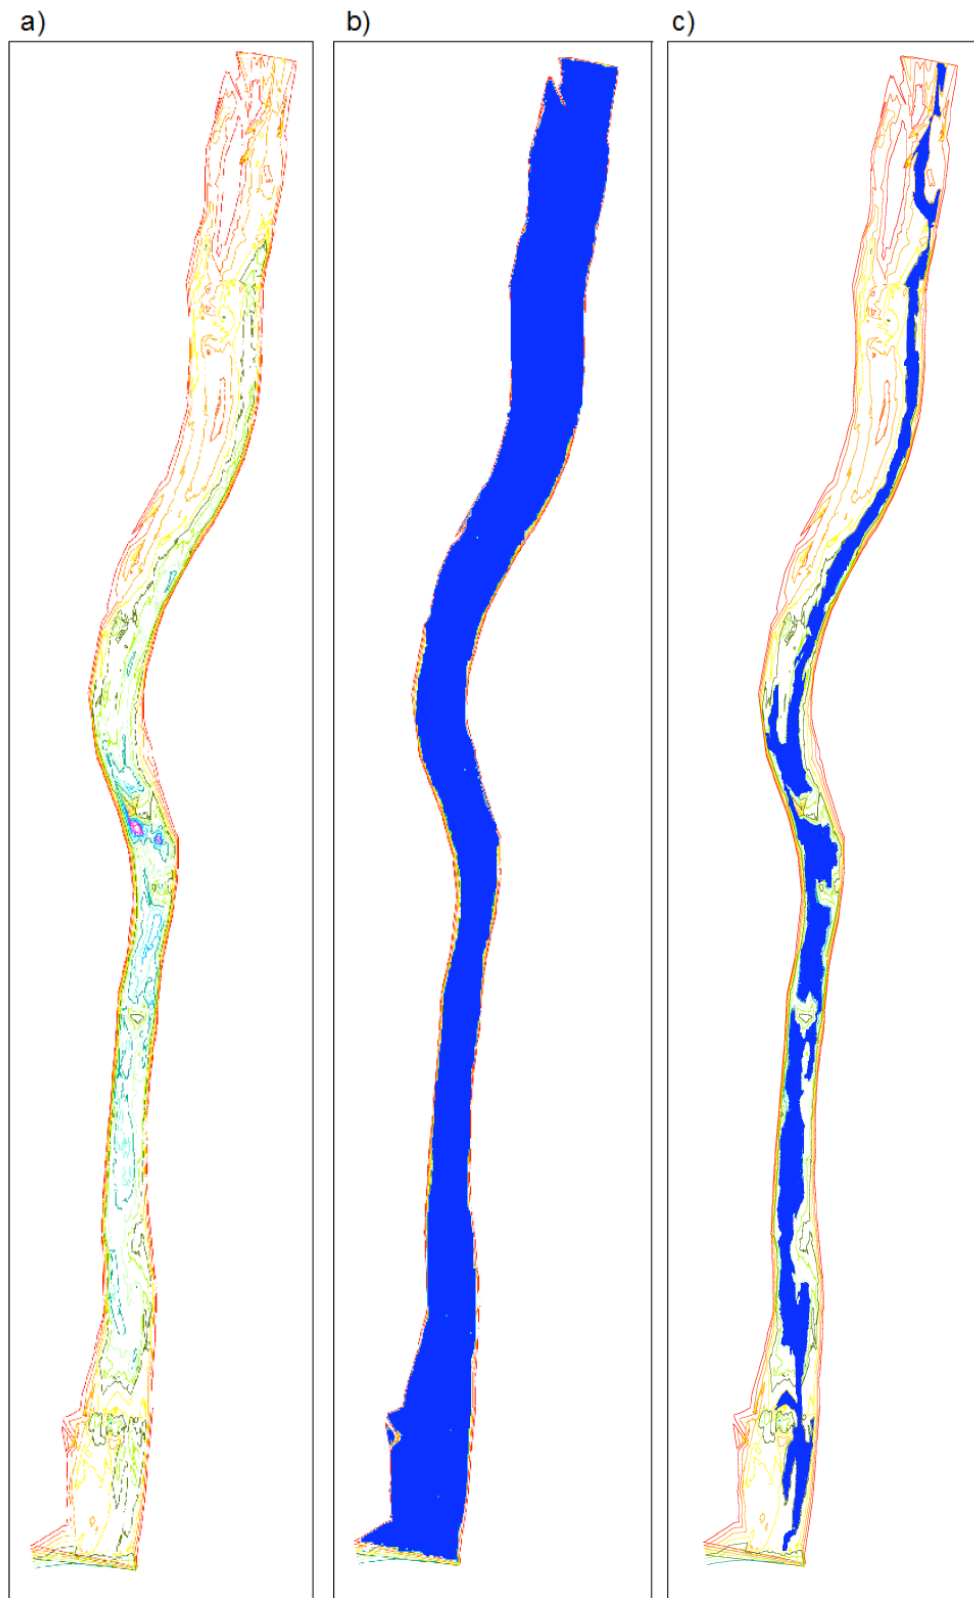
Figure 6 a) Stream channel bathymetry from Fifth Avenue Dam to Lane Avenue and comparison of the flooded area b) before and c) after dam removal to 80% stage reduction.

Figure 6a shows the bathymetry of the stream pool from the Fifth Avenue Dam to Lane Avenue. Under current conditions, the channel is entirely flooded at median flow. The shaded areas in Figures 6b and 6c show, respectively, the current flooded area at median flow and the area that can be expected to remain submerged if the stage is reduced by 80%. A high stage reduction (up to 80%) dramatically changes the flooded channel area or width in most areas (Table 3).
